**Lamar Headworks Rehabilitation**
Lamar, Colorado, USA

Products
**MEGAMIX II WITH BIO-SAN,
BIO-SAN C500**

Project Type
**HEADWORKS RESTORATION
AND PROTECTION**

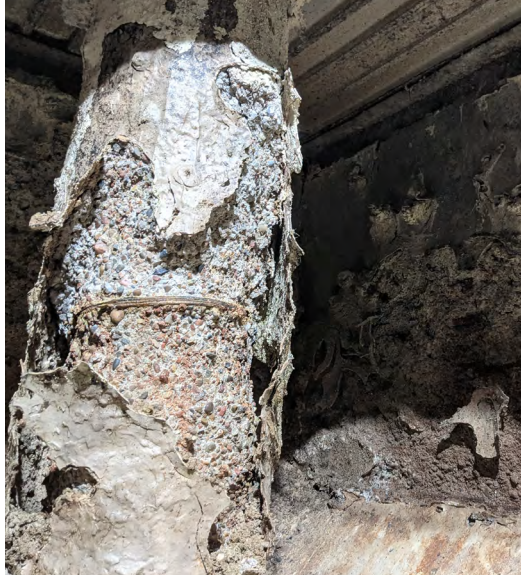
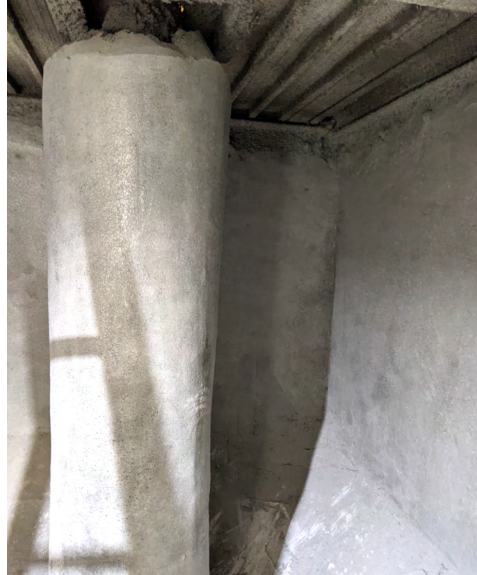
BEFORE & AFTER: The City of Lamar, Colorado, needed to restore its heavily corroded wastewater system headworks facility after just a few years of exposure to extremely high levels of H₂S. Remains of a failed epoxy coated concrete column can be seen at left. The city chose to repair and protect the structure with Xypex Megamix II with Bio-San (at right), which provides both crystalline waterproofing and inhibits microbial induced corrosion in a single repair mortar.

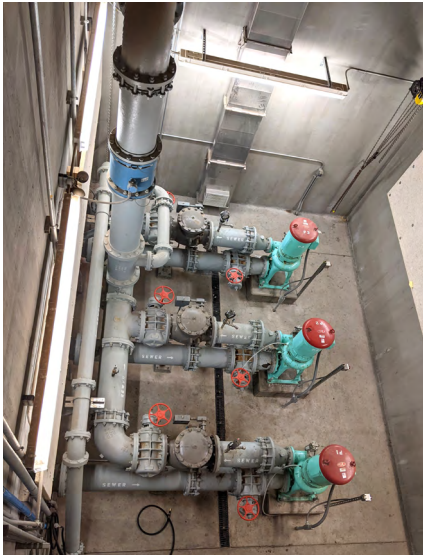
Fig 2 -- Half of the Lamar headworks is used as a pumping station to move wastewater out to a lagoon system just east of the facility. The other half is a wet well where influent is filtered.

The Lamar wastewater system is composed of 56 miles (90 km) of collection lines ranging in size from 6 to 24 inches (15 to 61 cm), three lift stations on the east edge of the city, and one main pumping (headworks) station to pump (fig 2) wastewater into treatment lagoons (fig 3).

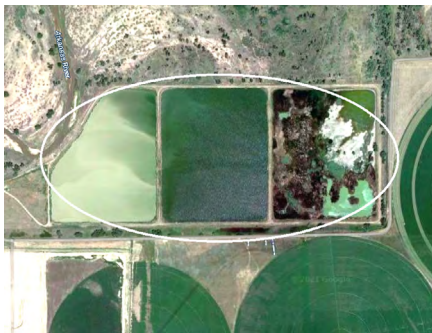
Fig 3 – The Lamar headworks facility is located about 1.5 miles (2.4 km) west of a three-cell lagoon system (circled). Wastewater is pumped from the headworks to the lagoons via a 24 inch (.6 m) force main pipeline.

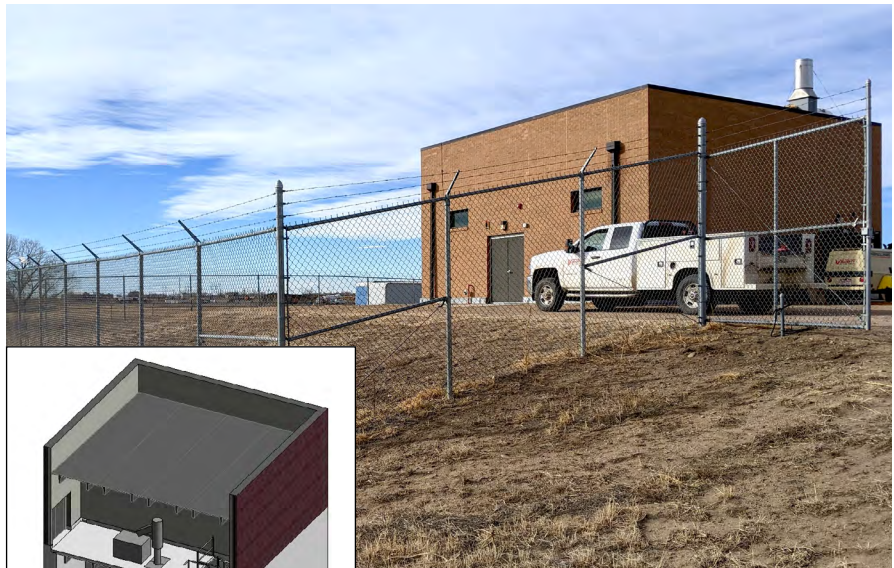
Fig 4 -- The Lamar, Colorado, headworks facility was built in 2010 to replace a lift station that had reached its end of life. Within a few years, the facility experienced significant corrosion due to excessive level hydrogen sulfide produced by the slow moving waste stream. In less than 10 years, a major restoration was required. Inset: Two-thirds of the Lamar headworks facility is located below grade, resulting in constant hydrostatic pressure from ground water.

The city completed the headworks facility in 2010 (fig 4) to replace a preexisting lift station that had reached the end of its useful life. Unfortunately, the new headworks facility has experienced accelerated corrosion due to high levels of hydrogen sulfide (H₂S) gas emitted from the slow moving sewage stream.

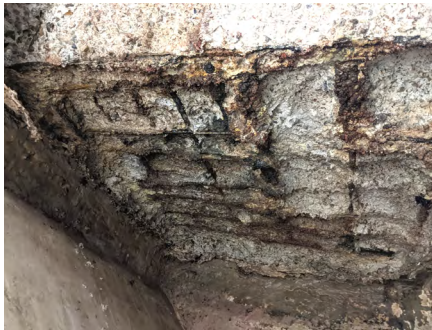
Such was the case with the Lamar headworks facility. In just a few years, the city was forced to address advanced corrosion in the young structure. The concrete wet well, where influent enters and large debris is filtered out, was losing concrete at a rapid rate. Microbial induced corrosion eroded the wet well interior so badly that up to two inches of concrete (fig 5) could be easily scraped off and even stainless steel components corroded away (fig 6).

Fig 5 -- Concrete structures were deeply damaged by biogenic corrosion, resulting in concrete spalling and exposed reinforcing steel. An epoxy coating was applied within a few years after the structure was built, but failed quickly.

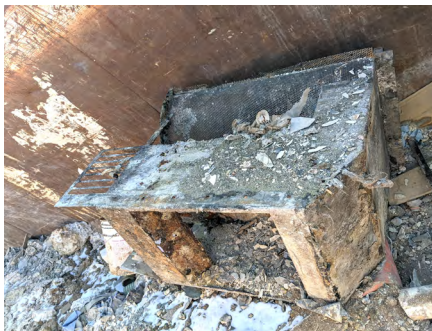
Fig 6 -- Even stainless steel was no match for the extreme corrosive effect of hydrogen sulfide gas and the resulting microbial induced corrosion (MIC). Here, the remains of a stainless steel filter are shown.

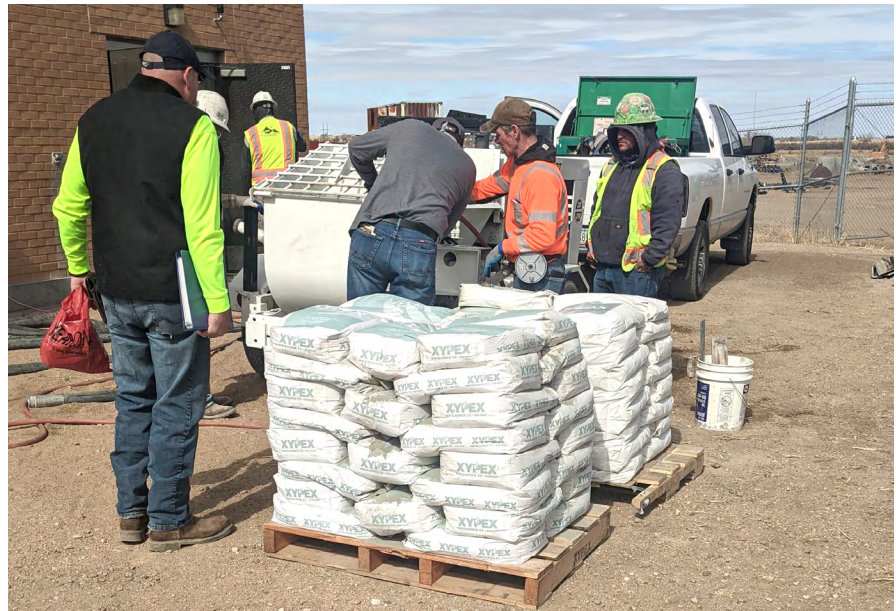
Fig 7 -- Colorado-based Advanced Shotcrete mixes Xypex Megamix II with Bio-San and pumps it nearly 30 feet below grade to spray apply it to the inner surfaces of the Lamar, Colorado, headworks facility.

JVA recommended that the headworks structure be restored using Xypex **Megamix II** with Bio-San, a resurfacing mortar formulated with Xypex **crystalline waterproofing technology** in combination with Bio-San bioactive mineral solids (fig 7). Megamix II with Bio-San provides chemical resistance to acids, sulfates, and chlorides, while also providing waterproofing, MIC resistance, and replacement of lost section thickness.

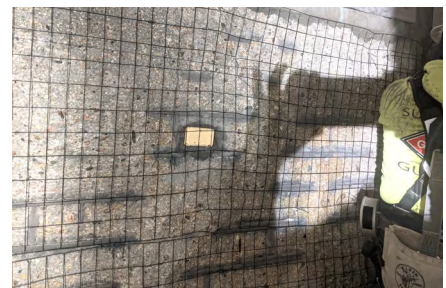
Fig 8 -- After hydrodemolition has removed all loose concrete and other debris from the wet well walls, exposed rebar is coated and sacrificial anodes are attached prior to the application of Xypex Megamix II with Bio-San.

Hydrodemolition was used to remove all unsealed concrete from the wet well. Exposed rebar was cleaned and coated. Sacrificial anodes were attached in several areas (fig 8). **Megamix II with Bio-San** was then spray applied by applicators Advanced Shotcrete, based in Watkins, Colorado, and hand finished (fig 9).

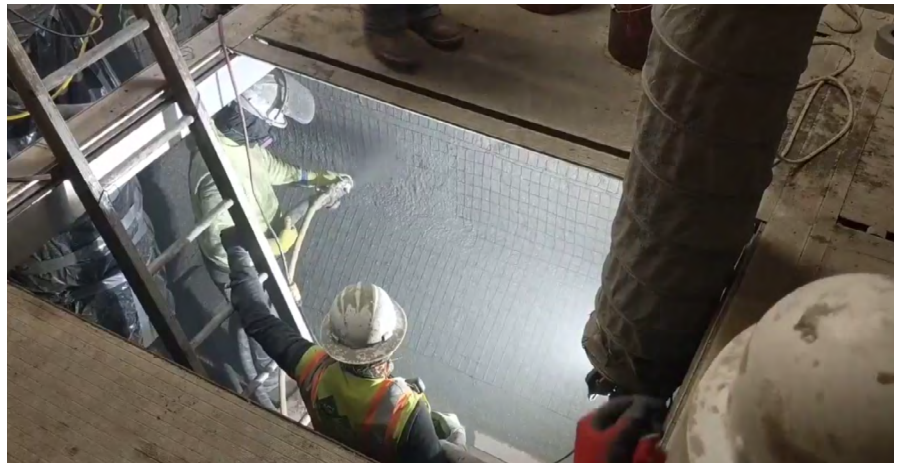
Fig 9 -- Applicator Advanced Shotcrete spay applies Xypex Megamix II with Bio-San during a restoration project at the Lamar, Colorado, headworks facility. In less than 10 years of service, extreme corrosion from excessive hydrogen sulfide gas caused rapid concrete spalling and metal corrosion.

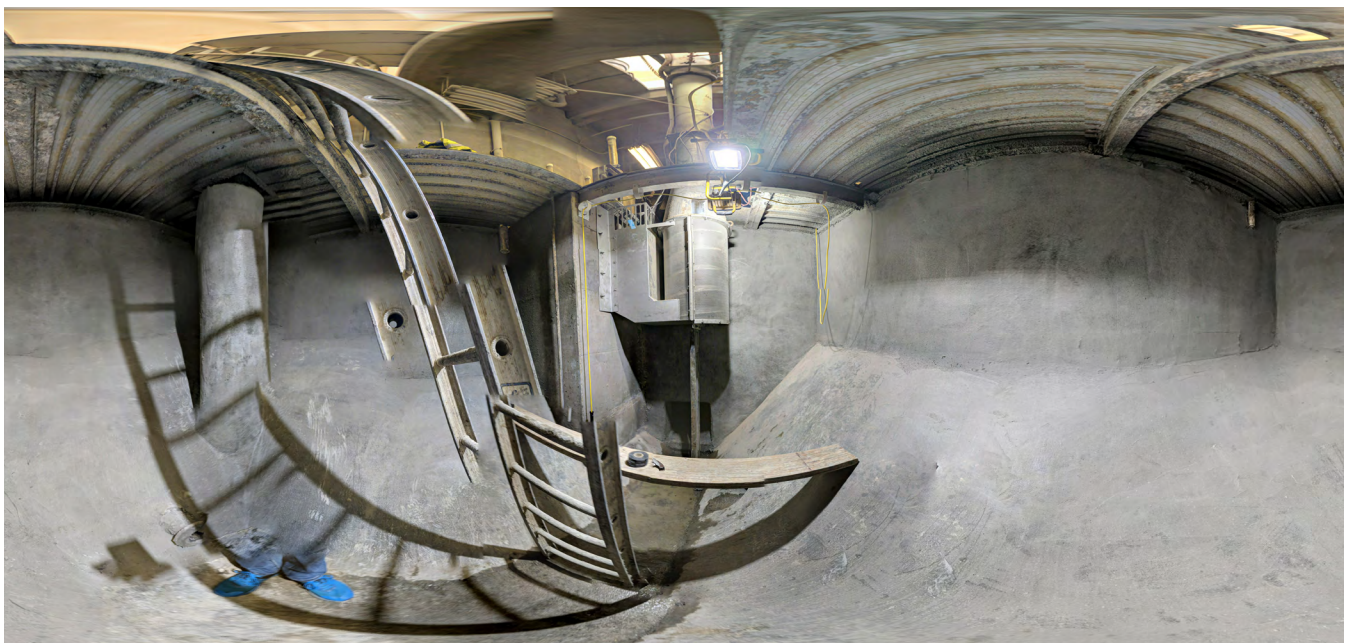
Fig 10 -- A 360-degree view of the headworks wet well upon completion.

“There are many, many situations where Xypex crystalline waterproofing, with and without Bio-San, is the right solution,” says Teunissen. “The Lamar headworks was a new structure that failed in just a few years. It was probably the worst corrosion rate I’ve seen in my career. We believe we have an excellent chance to succeed with the strategy we’ve chosen, combining Megamix II with Bio-San for surface restoration and H₂S reduction with Bioxide (fig 10).”
