## Nita Lake Lodge - Elevator Pit Repair

Whistler, BC, Canada

Project Type  
**ELEVATOR PIT**

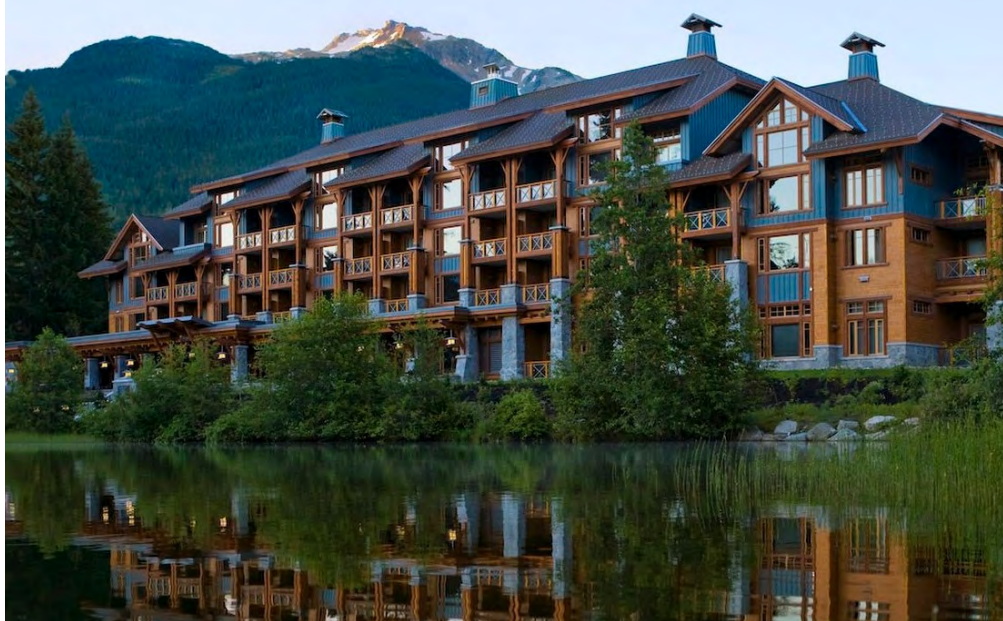
Nita Lake Lodge was built in the early 2000s and had, for many years, experienced flooding of one of its main elevator pits. The ingress and ensuing water levels into the pit caused the elevator to repeatedly lock at the ground floor. This did not allow the elevator to reach the main parking level.

was again inspected and was found to be completely dry with no evidence of leaking. The maintenance staff at Nita Lake Lodge confirmed that since the repair the pit has remained dry. Evidence of Xypex crystalline growth in the interior of the elevator pit confirms the continued presence of water coming from the exterior and the success of the Xypex application.

In early 2017, a consultant's report recommended the use of Xypex products to repair the leaks. The work was commissioned in mid-2017 and the elevator pit was sealed against water inflow using Xypex [Patch'n Plug](#) and [Concentrate](#). In the spring of 2018, during the annual snow melt the elevator pit
